LINCOLN-ELIOT ELEMENTARY SCHOOL

EXISTING CONDITIONS ASSESSMENT

NEWTON, MA

SECTION 3A – 150 JACKSON ROAD EVALUATION OF EXISTING CONDITIONS

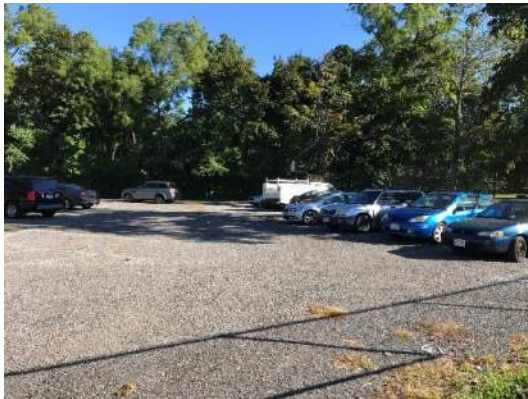
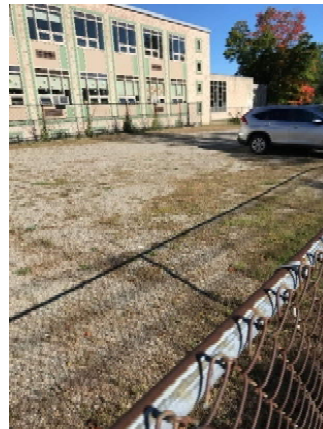
Photos 1 & 2: Gravel parking lots at northwest side of site (left photo) and east side of site (right photo)

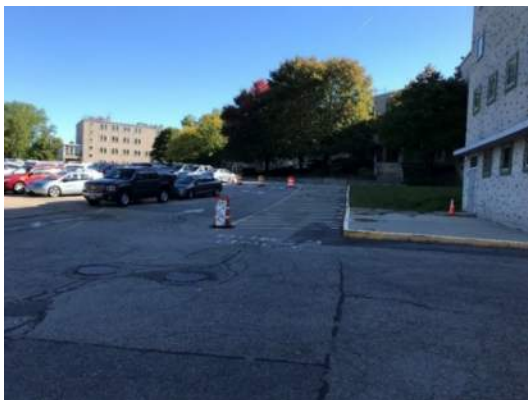
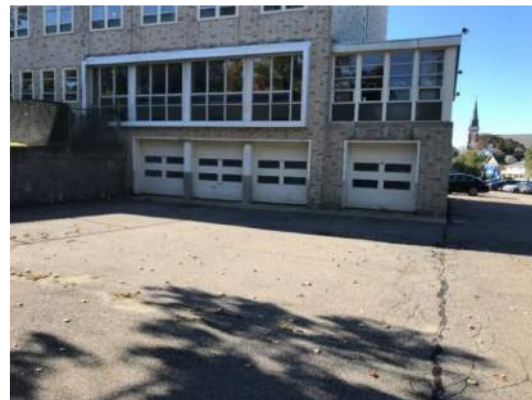
Photos 3 & 4: Entrance signage and striping for vehicular access (left photo) and parking garage doors (right photo)

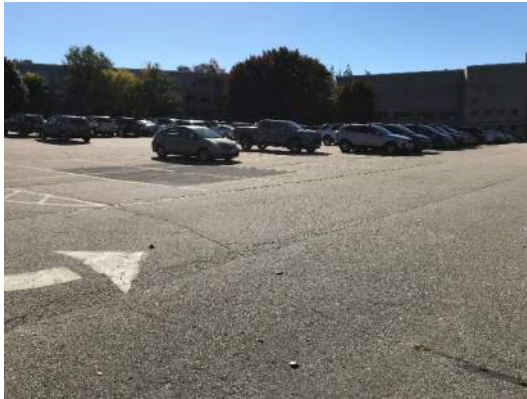
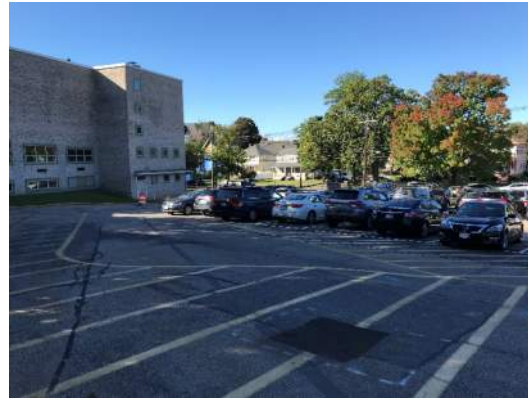
The existing main parking lot pavement is old and shows indications of previous repairs including patching, seal coating, and crack sealing. The existing pavement should be further evaluated for rehabilitation given the existing poor condition.

Photos 5 & 6: Main parking lot pavement surface condition (both photos)

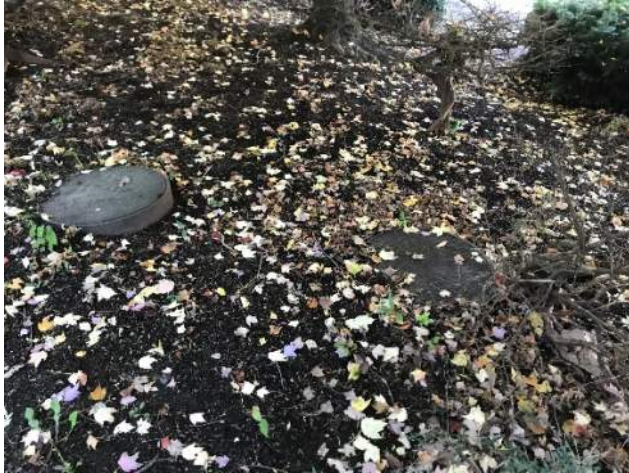
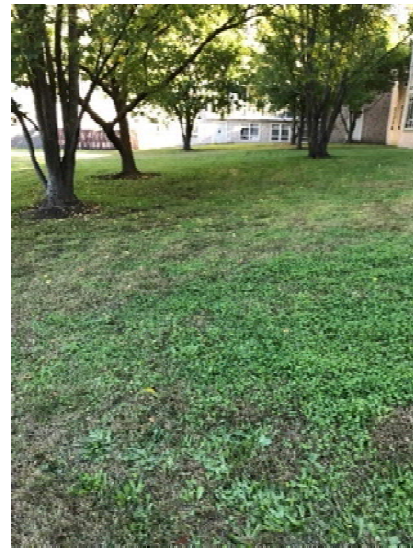
Record documents indicate that the building's sewer service is routed to the City main by a private sewer main leaves the northern portion of the building, running southerly parallel to the west side of the building and then turning west to connect to the City of Newton sewer main system in Jackson Road. Once connecting in Jackson Road, the City sewer main continues westerly to a main in Wilshire Street. Sewer manholes indicated on record documents with the routing above were observed in the field. Large, mature trees were also observed near the existing sewer main and would need to be evaluated if modifications to the existing sewer main were proposed. Record documents indicate the existing sewer pipe is a 6-inch vitrified clay pipe. Vitrified clay pipe does not meet current code and would need to be replaced if improvements were proposed to the building.

Record documents also note that the sewer service for the abutter to the south of the site connects to the sewer manhole within the private site. A manhole was observed on the abutters property in the approximate location shown on record plans. Additional sewer main video inspection should be conducted to determine the condition existing private main's pipe material, condition of the pipe, and routing of pipe through the site and from abutters.

Photos 11 & 12: Sewer and drain manholes observed at the site in the location noted on record documents (left photo) and large, mature trees located near the existing sewer and drain mains (right photo)

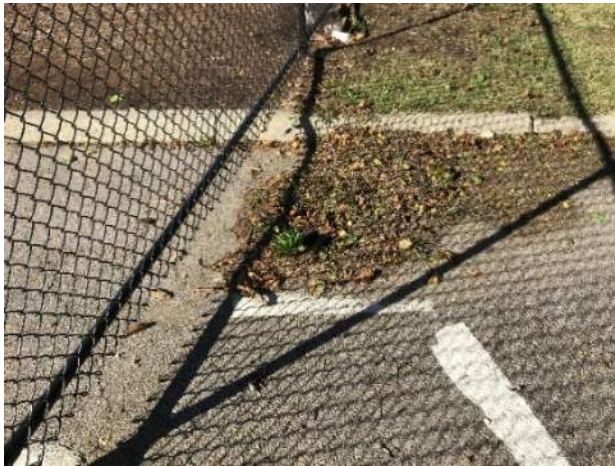
The existing site has minimal existing closed storm drainage facilities onsite according to record documents and site observations. Two (2) catch basins were observed on the western and lower side of the site. One (1) was located in the main parking lot and one (1) was located in the parking lot on the south side of the building. Neither catch basin appeared to provide enhanced level of pre-treatment, and record documents do not indicate that the site has a stormwater management system to mitigate for stormwater peak rates of runoff or stormwater volumes leaving the site. Stormwater that hits the vehicular traveled portions of western side of the site sheet flows westerly to the catch basin or into the landscaped areas adjacent to the Jackson Road property line. No catch basins or a closed drainage system were observed on the eastern side of the site. Stormwater that hits the eastern side of the site sheet flows into the landscaped areas adjacent to Waban Street and Walnut Park.

Photo 13: One of the observed catch basins on site located near the parking on the south side of the building, covered in leaves

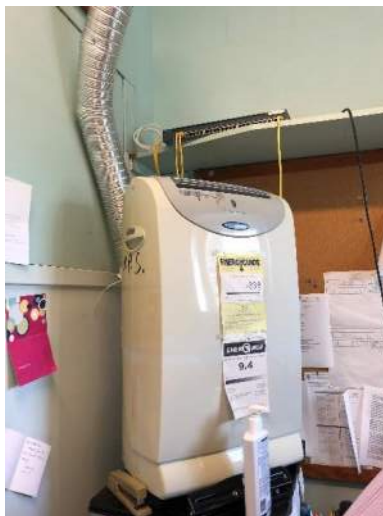
The main building does not have a central air conditioning system. Many rooms are air conditioned by window AC units. The Custodian's office has a portable AC unit installed.

Custodian Office - Portable AC Unit

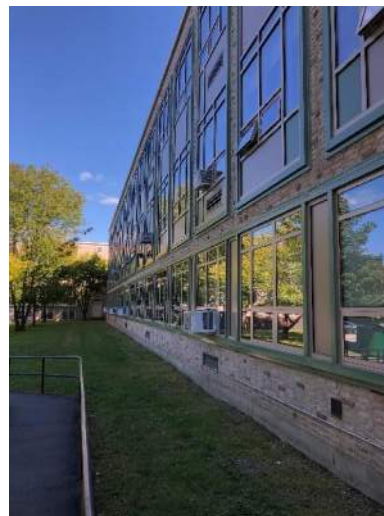
Window AC Units

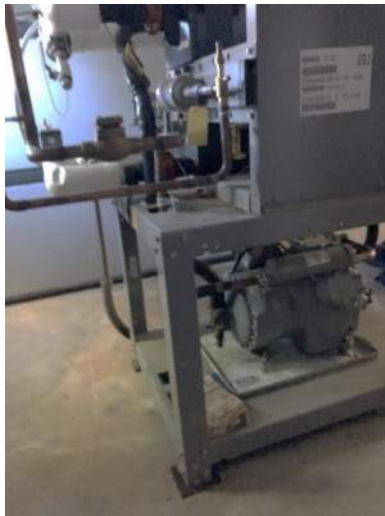
The Chapel and Rectory areas appear to have an air conditioning system installed. However, it is our understanding that the system is not utilized. There is a Carrier indoor split chiller installed in the mechanical room which is connected to a ducted air cooled condensing unit that is connected to intake and relief air louvers in the mechanical room. The chiller appears to be in good condition and was installed in recent years. The associated condensing unit appears to be older and in poor condition. The chiller is capable of providing chilled water to the Chapel/Rectory area air handling units.

Chapel – Chiller

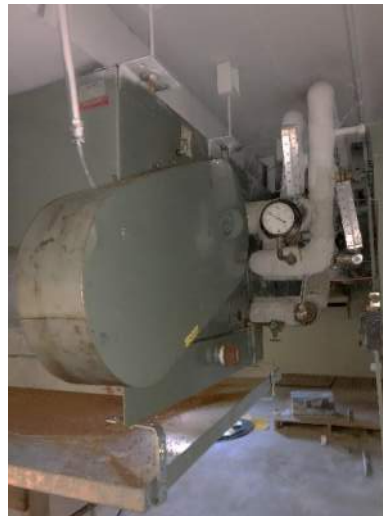
Chapel – Air Handling Unit

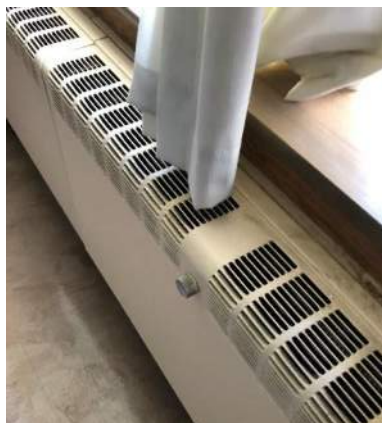
Hot water Fin tube Radiation

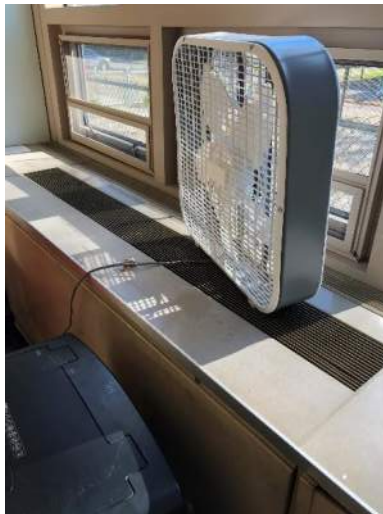
The majority of classrooms are heated and ventilated by classroom vertical wall mounted unit ventilators with hot water heating. The units appear to be originally installed equipment from 1966, and were manufactured by Nesbitt. The unit ventilators are in poor condition, past their expected service life and in need of replacement. There are approximately 42-unit ventilators located throughout the building (including unit ventilators that serve the Cafeteria). The upper level classrooms and library are no longer occupied. There have been numerous piping and valve leaks associated with the unit ventilators that serve these areas. Several of the unit ventilator filters observed in unoccupied areas were extremely dirty and have been disassembled.

First Floor – Unit Ventilator

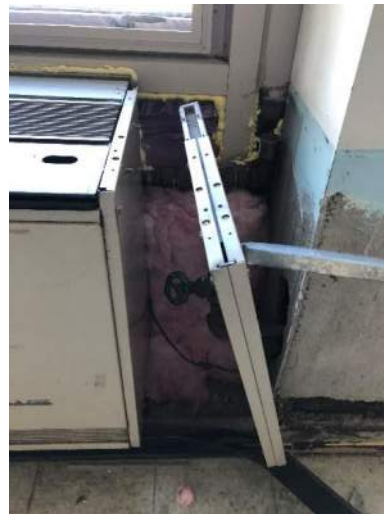
Second Floor Unit Ventilator

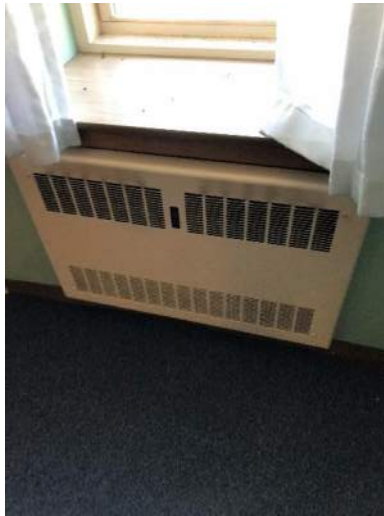
The majority of the Convent building is heated by hot water radiation and convectors. Supplemental electric heating was also installed in areas. The Chapel and Rectory areas of the building are served by air handling units that appear to have both heating and air conditioning capability. However, it is our understanding that the air conditioning system is not utilized. The heating and air handling equipment is originally installed equipment that needs replacement.

Hot Water Convector

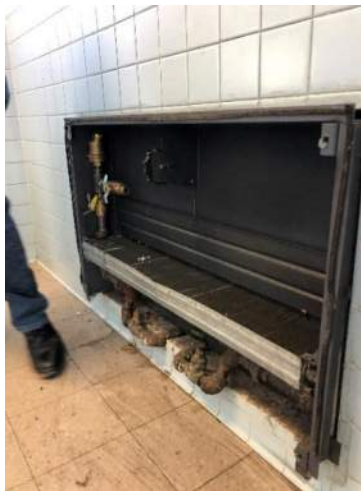
Corridors and entryways are heated by hot water radiation heating equipment that is original to the building. Several fin tube radiation and cabinet unit heater enclosures appear to be missing or damaged.

Hot Water Convactor

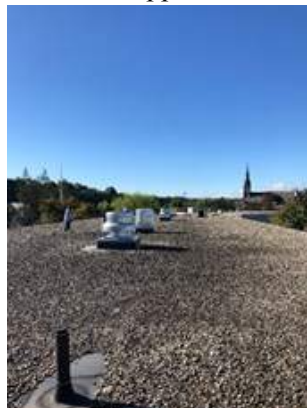
The majority of exhaust air ventilation for the building is provided by roof mounted exhaust air fans. Approximately half of the existing exhaust air fans appear to have been replaced in recent years.

Roof Exhaust Fans

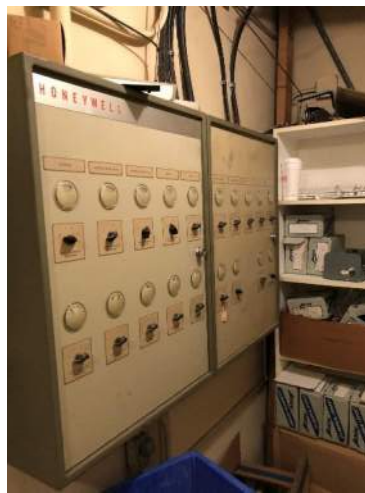
The building control system is a pneumatic control system. The control system consists of air compressors, air dryer, pneumatic control panels and pneumatic air tubing system. The main control panel was manufactured by Honeywell. The majority of control system components are originally installed equipment and systems. It is our understanding that the control system experiences numerous air leaks and does not provide adequate temperature control for many areas of the building.

ATC Control Panel

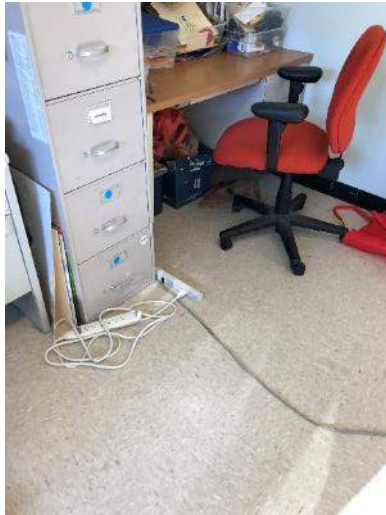
Extension Cord

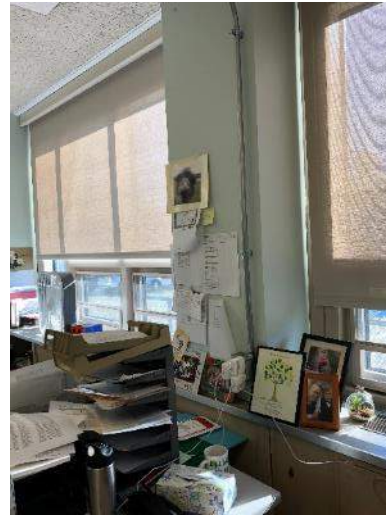
Added receptacle that is full

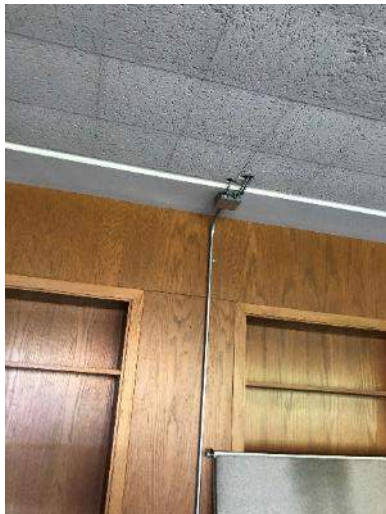
Added surface receptacle

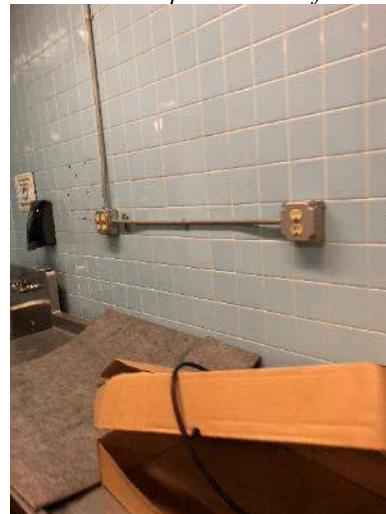
Kitchen Non-GFI Receptacle

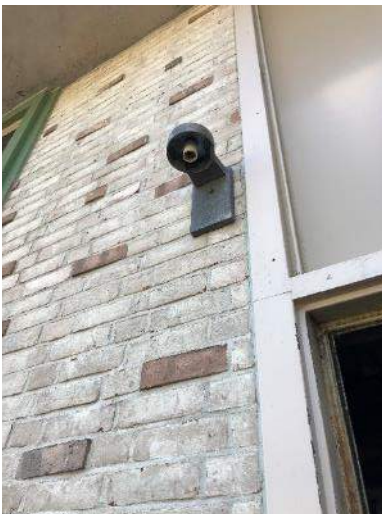
Damaged Light

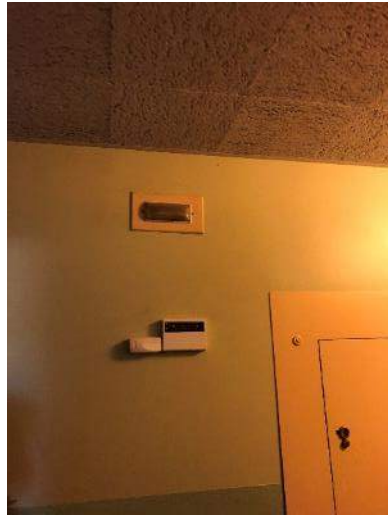
The emergency lighting throughout the facility is fed via the emergency generator. The emergency lighting system is a normally off system. The custodial staff noted that the light levels were very low. There is no separation of life safety and optional standby loads. The emergency generator is located in the Boiler Room. The generator is beyond its useful life. The emergency system should be replaced in its entirety. Battery units have been added throughout the facility to supplement the failing normally off emergency lighting.

Normally Off Emergency Light Fixture

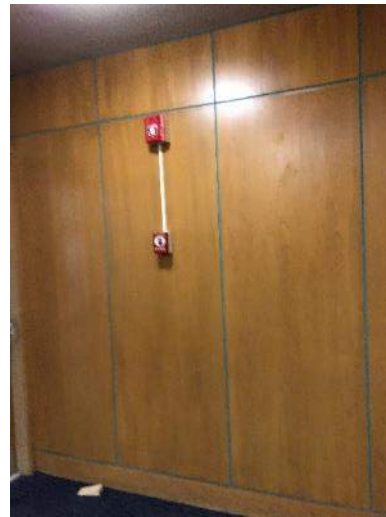
*Fire Alarm Notification Appliance
& Non-ADA compliant pull stations*

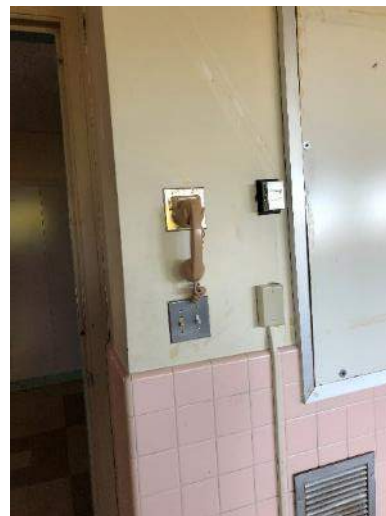
The handset is mounted above 54" A.F.F. which is an ADA violation. The system is antiquated and beyond its useful life. The paging system should be replaced in its entirety. The paging system is a Bogen Model MCP25A.

Classroom Handset

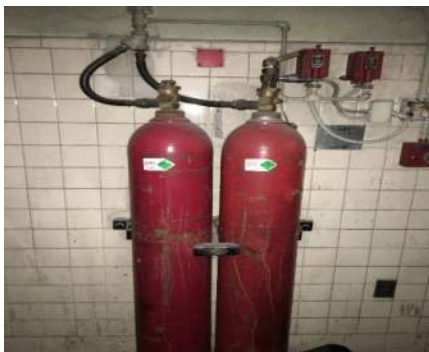
There is no active fire suppression system in the building located at 150 Jackson Road. Building has no automatic sprinklers, no hose cabinets or fire department standpipes present. The existing kitchen located adjacent to the Cafeteria, has a High Pressure CO₂ system, which appears to be still in use.

High pressure CO₂ System storage tanks

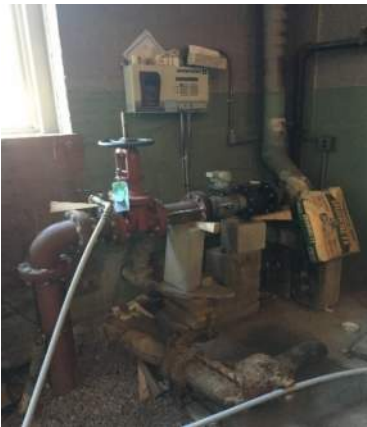
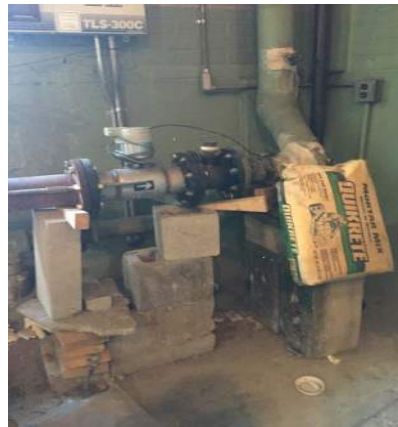
The domestic cold water service entrance to facility is located in the boiler room in the basement. It is 4" in size with a new backflow preventer installed recently. The domestic cold water system consists of copper pipe with soldered fittings. It is expected that the solder used in the system has a significant lead content. A couple of drinking fountains were shut down due to lead content in water. In addition, existing domestic cold water piping appears to be original and in poor condition, has outlived/exceeded its useful life and is not expected to last more than a few years without exhibiting possible failures. Infact, one of the bathrooms in the first floor was closed because of pipe break.

New backflow preventer with concrete block used as support.

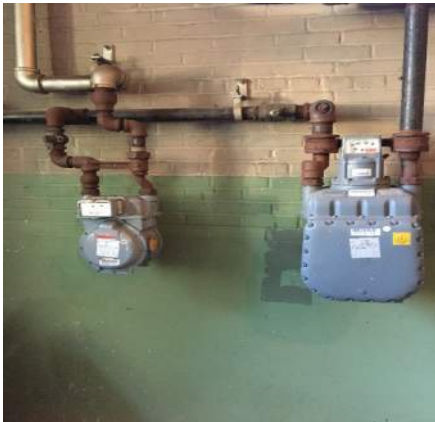
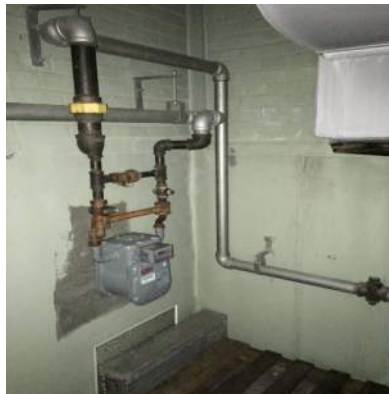
There are two gas service entrances and are installed inside the building. One serves the old convent area boilers and convent kitchen appliances. The other gas service has two meters with one serving the emergency generator and the other serving the hot water heater, boilers and kitchen appliances near the cafeteria. Gas piping within the mechanical boiler room appears to be in fair condition.

Gas meters in boiler room, below cafeteria Gas meter in the old convent area

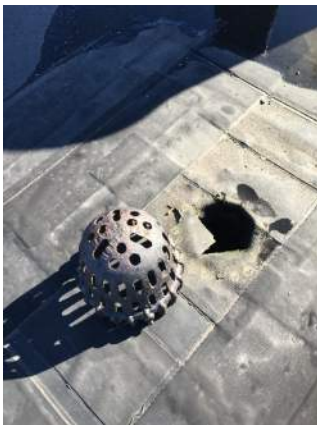
The building has a flat roof with different levels and roof drains for storm drainage. Storm drainage piping is original and has outlived/exceeded its useful life. It is not expected to last more than a few years without exhibiting widespread problems and possible failure. The roof drains all seem to be bad condition. The drains consisted of cast metal dome tops with cast iron bodies and some were not clamped to the roof. Piping observed was No-Hub cast iron soil pipe and fittings. No problems with the roof drain system were observed. If areas have had blockages in the past we would recommend video inspection of those, underground lines to verify their condition and address them accordingly.

Roof drain above school

- Recommend video inspection of underground sanitary and storm piping to verify their condition and address them accordingly.

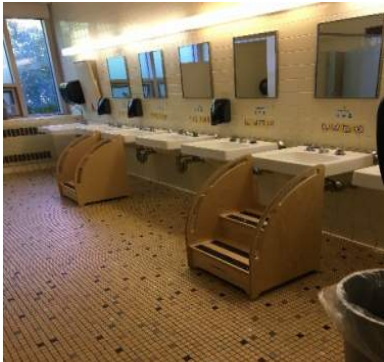
Most of the fixtures are of original vintage condition. All observed fixtures are not of water saving type. Due to the fixture age, maintenance is routinely required on faucets, toilet fill valves, to keep fixture operational. Water closets are not of consistent style in the building. All fixtures are wall mounted type. Most of flush valve are not equipped with water conserving 1.6 gallon per flush type valve. The lavatory sinks are of the wall hung type and has manual faucet. The faucets are not metered and do not comply with latest water conservation requirement. Majority of toilets are not equipped with ADA / MA accessibility compliance toilet fixtures. Urinals have flush valve. The existing buildings plumbing systems will need to be verified for adequacy in quantity based on planned occupancy use. Drinking fountains observed are not ADA compliant. There are no sinks in classrooms. In the kitchen near the cafeteria, three-bowl pot/scullery sink has above ground grease trap connection prior to regular sanitary connection. Janitor closets in the facility has wall mounted utility sinks. The faucet of janitor sink has no vacuum breaker for backflow prevention. The old convent building has showers, which are not used.

Lavs at the boy's room
