LINCOLN-ELIOT ELEMENTARY SCHOOL

EXISTING CONDITIONS ASSESSMENT

NEWTON, MA

SECTION 3A – 150 JACKSON ROAD EVALUATION OF EXISTING CONDITIONS

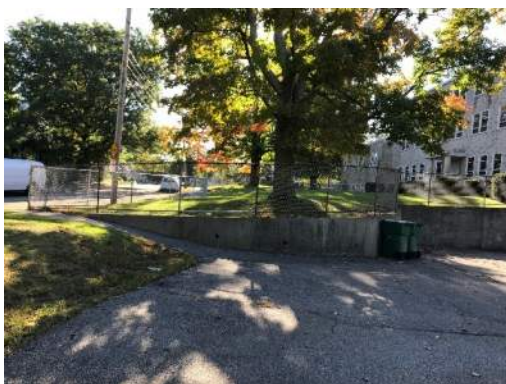
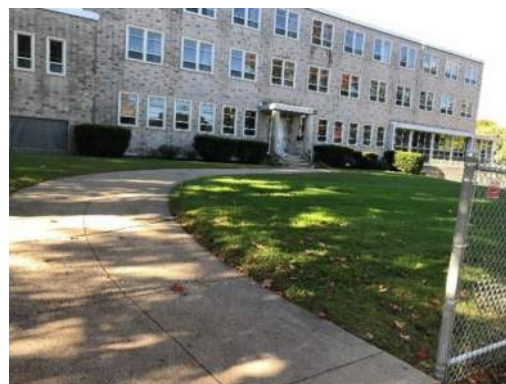
Pedestrian entrances from Waban Street to access the parking lot and the building do not appear to meet current ADA regulations due to the slope of the walkways and/or stair access into the building. One (1) of the entrances to the building from Walnut Park has been retrofitted with a ramp, in order to provide ADA access up the entrance stairs to the lobby. The ramp should be reviewed for compliance with current ADA regulations.

Photos 7 & 8: Pedestrian access from Waban Street to the main parking lot (left photo) and Waban Street pedestrian access to the building (right photo)

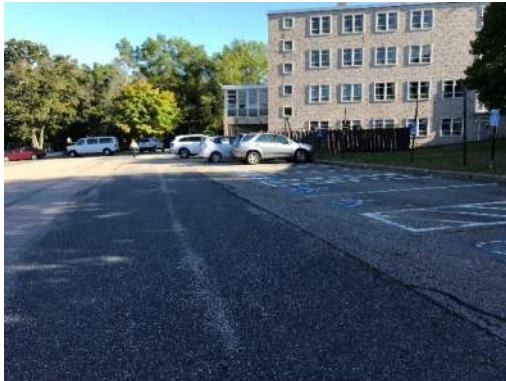
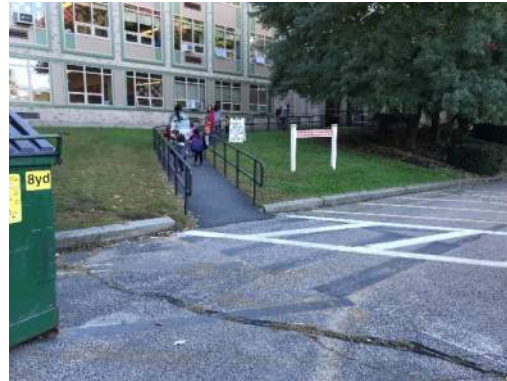
Trash dumpsters and recycling storage and pickup for two (2) large containers is located in the main parking lot, close to the building and adjacent to the main entrance and the accessible parking spaces.

Photos 9 & 10: Accessible parking spaces and one (1) of the dumpsters located near the main entrance

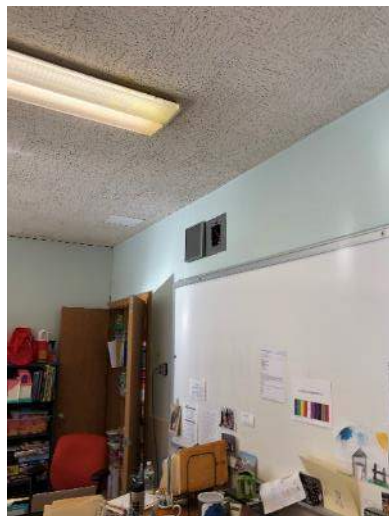
Clock/ Speaker

The handset is mounted above 54" A.F.F. which is an ADA violation. The system is antiquated and beyond its useful life. The paging system should be replaced in its entirety. The paging system is a Bogen Model MCP25A.

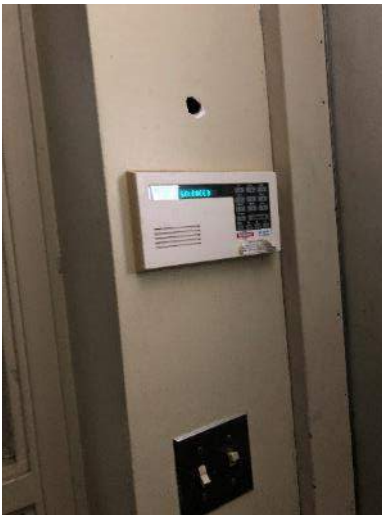
Intrusion Keypad

An intrusion system is present along with access control at key entry points. The access control system is Lenel and is a district standard. There are also Aiphone video intercoms on key entry points.

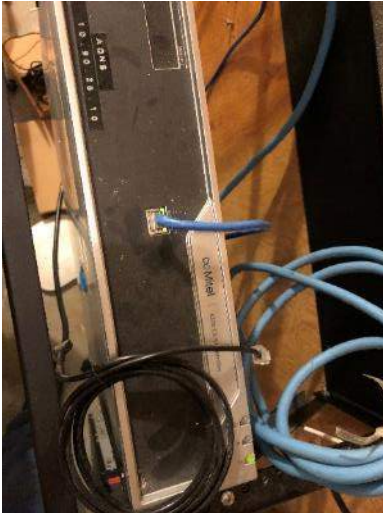
Mitel VOIP System

A single closet is unable to serve the entire school due to ethernet wiring distance limitations. There is no active data on the third floor for this reason. Wireless access points are limited, there is not 100% coverage in the building.

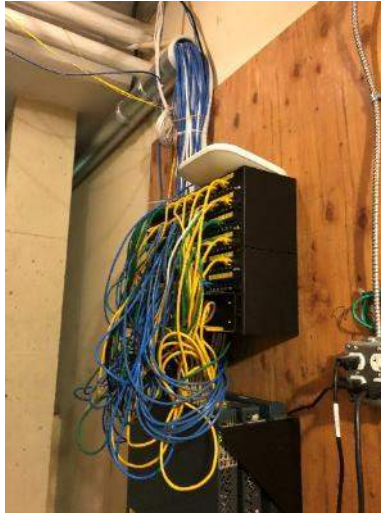
MDF Data Rack

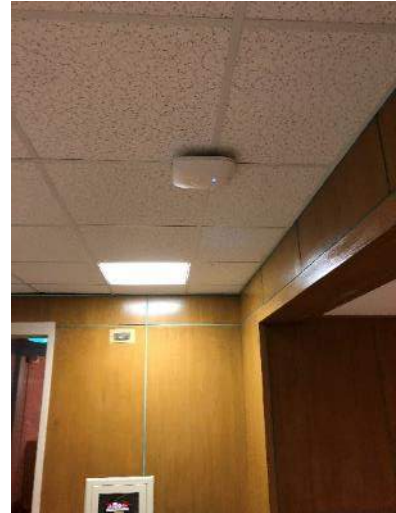
Wireless Access Point

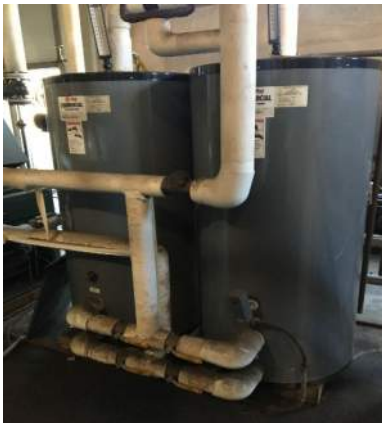
Domestic hot water for the facility is supplied from gas fired hot water boiler and is stored in two (2) 115 gallon storage tanks. The storage tanks appears to be installed in 2007. Original hot water storage tank is abandoned in place. The hot water boiler appears to be original to the building and is located in the boiler room in basement, below the cafeteria.

115 Gallon storage Tanks

the fittings or contain high lead content brass pipe. We recommend pressure test and water quality test and monitor for any possible lead contamination. If the project involves substantial renovation, we would recommend complete replacement of all domestic water piping, valves and accessories and install dual temperature system which would be required to satisfy code requirements for occupant fixtures (bathroom sinks) to discharge hot water at a temperature no greater than 110-112°F for safety reasons, whereas the service fixtures (janitor's sinks, kitchenette sinks, etc) are required to have hot water temperatures in excess of 120°F for sanitation reasons. The two temperature tempering system can be addressed via a separate pipe system or locally at individual fixtures.

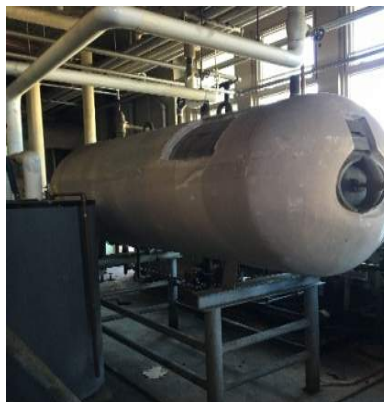
Original storage tank abandoned in place

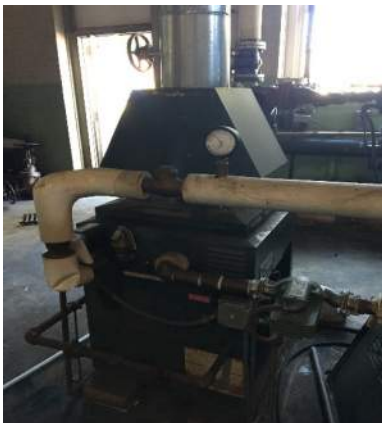
Hot water Heater

Pipe insulation and valves appear to be original and in poor condition. Asbestos pipe insulation is suspected. Pipe labels, flow arrows and valve tags were not installed. Separate backflow preventers for non-potable hot water to the dish washer is installed. The temperature of the hot water supply is maintained through master thermostatic mixing valve. No problem with pressure, quality and hot water temperature were reported during our site visit. However, due to the pipe age, there is a probability that the water service line could be deteriorated and lead containing solder may exist in

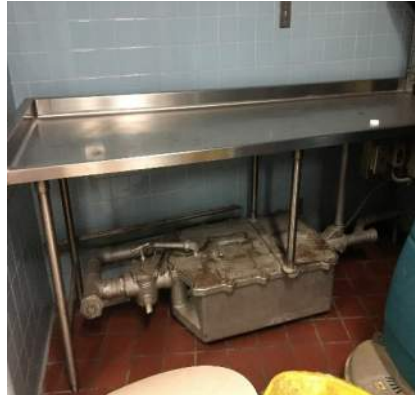
Grease interceptor in kitchen, near cafeteria

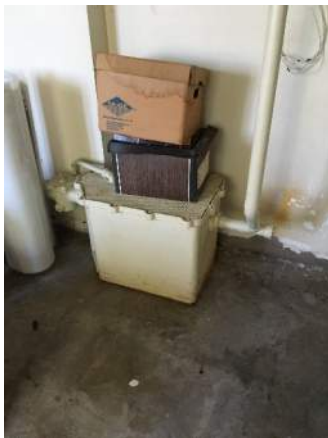
Grease interceptor in convent side

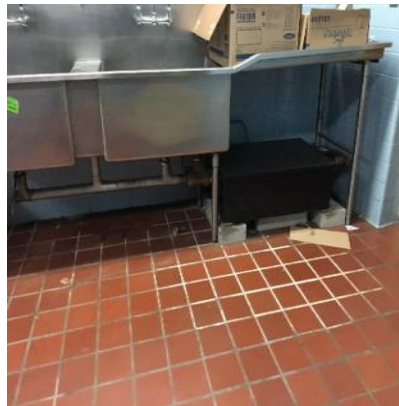
Grease interceptor in kitchen, near cafeteria

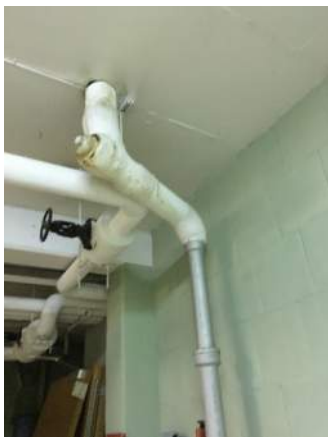
The sanitary sewer flow is by gravity and exits the building to a municipal sewer system at three locations with two 5" cast iron lines and one 4" cast iron line. Soil piping observed was a combination of extra heavy cast iron, with bell and spigot joints. Visible vents are galvanized steel with threaded fittings. The existing sewer piping, hangers in boiler rooms of building are in fair condition. No separate kitchen waste system is present in the facility.

Waste pipe in boiler room

- Recommend video inspection of underground sanitary and storm piping to verify their condition and address them accordingly.

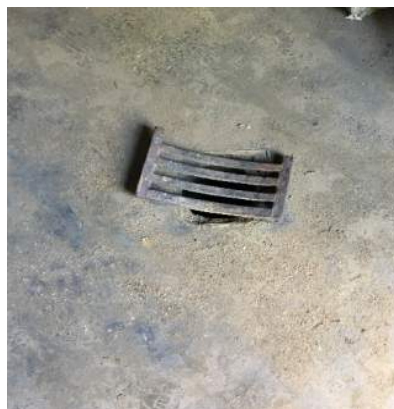
floor drain in boiler room

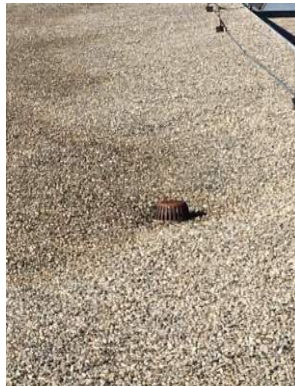
The building has a flat roof with different levels and roof drains for storm drainage. Storm drainage piping is original and has outlived/exceeded its useful life. It is not expected to last more than a few years without exhibiting widespread problems and possible failure. The roof drains all seem to be bad condition. The drains consisted of cast metal dome tops with cast iron bodies and some were not clamped to the roof. Piping observed was No-Hub cast iron soil pipe and fittings. No problems with the roof drain system were observed. If areas have had blockages in the past we would recommend video inspection of those, underground lines to verify their condition and address them accordingly.

Roof drain above old convent

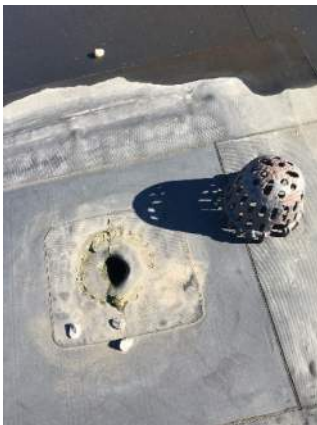
Roof drain above school

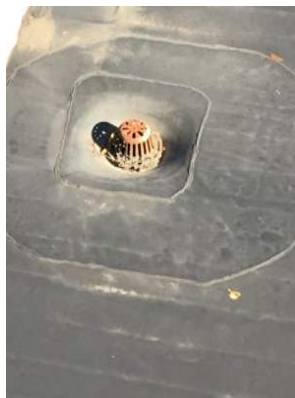
Roof drain above cafeteria

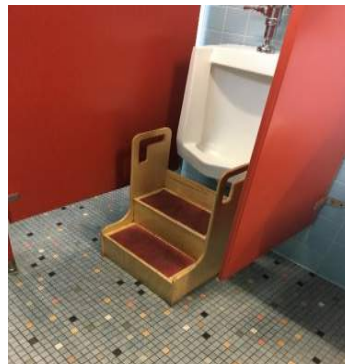
Most of the fixtures are of original vintage condition. All observed fixtures are not of water saving type. Due to the fixture age, maintenance is routinely required on faucets, toilet fill valves, to keep fixture operational. Water closets are not of consistent style in the building. All fixtures are wall mounted type. Most of flush valve are not equipped with water conserving 1.6 gallon per flush type valve. The lavatory sinks are of the wall hung type and has manual faucet. The faucets are not metered and do not comply with latest water conservation requirement. Majority of toilets are not equipped with ADA / MA accessibility compliance toilet fixtures. Urinals have flush valve. The existing buildings plumbing systems will need to be verified for adequacy in quantity based on planned occupancy use. Drinking fountains observed are not ADA compliant. There are no sinks in classrooms. In the kitchen near the cafeteria, three-bowl pot/scullery sink has above ground grease trap connection prior to regular sanitary connection. Janitor closets in the facility has wall mounted utility sinks. The faucet of janitor sink has no vacuum breaker for backflow prevention. The old convent building has showers, which are not used.

Urinal in boy's room

During a substantial renovation and addition project, code would require that all the water closets, lavs, etc. be modified to be of the water conservation type and that of those, a certain percentage would be required to be ADA complaint. In addition, water of the appropriate temperature would be required to be supplied to fixtures whether by a dual temperature piping system or with the use of tempering valves and/or fixtures.

- Most plumbing fixtures are original to the building and near its useful life. Any substatial renovation will need to meet ADA /energy code requirements and plumbing fixture quantity will be required to be reviewed to meet population counts.

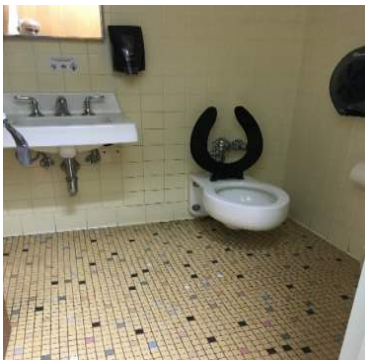
Water closet and lavatory in toilet room

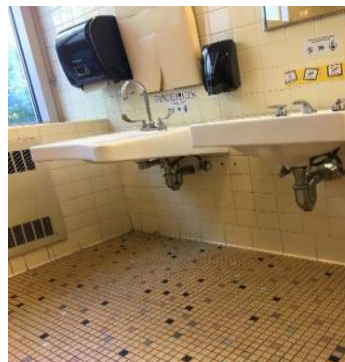
Lavs in boy's room

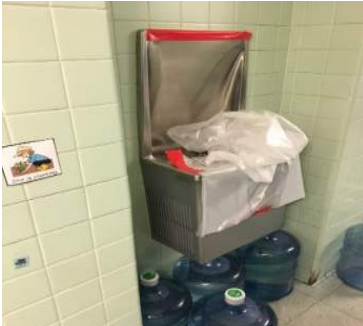
Drinking fountain

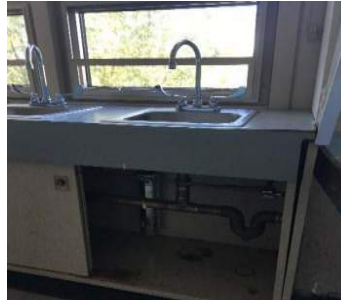
Sinks in old labs

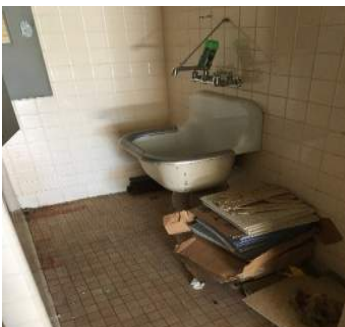
Mop sink in janitor's closet

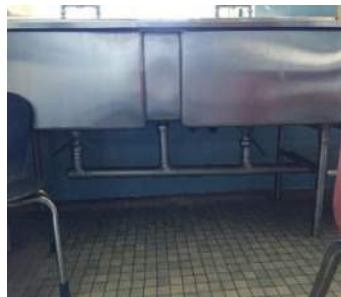
Three-bowl pot/scullery sink in kitchen, near cafeteria

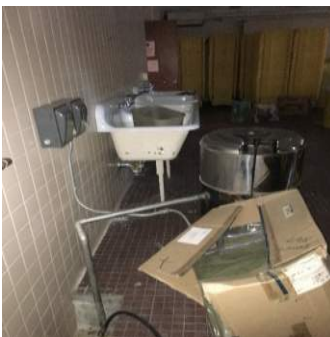
Cleaning room mop sink in convent

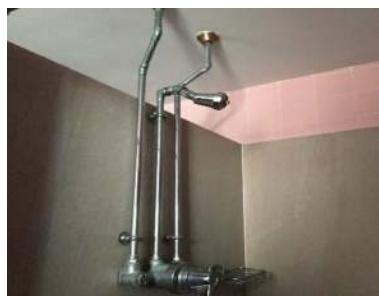
Shower room in convent
